Implementation of arc flash mitigating solutions at industrial manufacturing facilities

David B. Durocher
Senior Member, IEEE
Global Industry Manager
Eaton
26850 SW Kinsman Road
Wilsonville, OR 97070 USA
davidbdurocher@eaton.com

Abstract

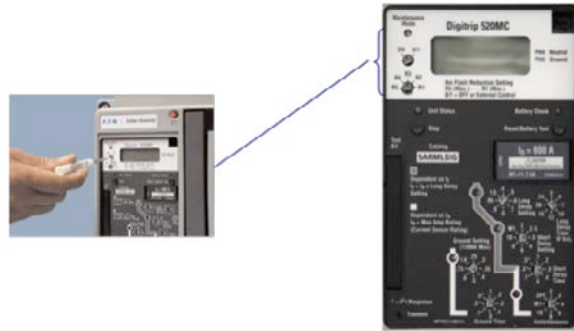
Figure 6
Air circuit breaker included an integral trip unit with Arcflash Reduction Maintenance System (ARMS) capabilities.

Figure 6 shows the typical integral trip unit of the air circuit breaker and the ARMS or maintenance setting. Local and remote enabling and indication capabilities are provided, allowing consideration for Lock-out/Tag-out procedures from outside the arc flash hazard area.

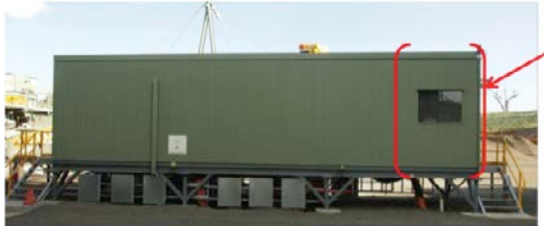
Airlock Room Segregated from Main Switchroom

Figure 8
The main switchroom is designed with an airlock section where the ARMS switch and confirming indicating light are mounted. This functionality is activated prior to maintenance persons gaining access to the main switchboard area.

To ensure an additional level of safety, the design of the main switchroom included an airlock section as shown in **Figure 8**. The airlock room is physically isolated outside of the main switchroom where the switchboard is located. An ARMS activation switch and remote maintenance mode indication light is located in the airlock room. In addition, motion detectors were installed inside the main switchroom that also engaged the maintenance mode. This was a back-up safeguard in the event the ARMS switch was mistakenly not engaged by the operators or perhaps non-qualified persons who somehow have access to this space. Indication of the ARMS mode also is connected to the SCADA system so plant operators were aware of the setting.

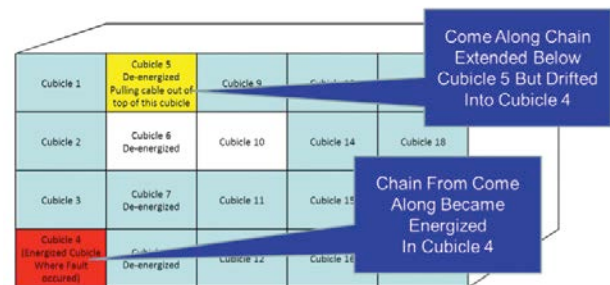
Figure 10
Low voltage assembly involved in planned energized work. The planned task included removing cables from de-energized Cubicle 5 while Cubicle 4 in an adjacent section was still energized.

A chemical processing facility in the U.S. was planning energized work for an existing 480 V low voltage switchgear assembly that was an existing piece of equipment in the plant. During a process upgrade in the facility, an energized work permit was issued to remove three abandoned load conductors from an existing 480 V low voltage switchgear assembly cable compartment. The work permit was very detailed and included tools planned for use in the project and required PPE for workers performing the task based on the incident energy defined by a recently completed arc flash hazard assessment. The defined task for the work order required the site contractor to use a nylon rope, which was typical with this type of project, disconnecting the de-energized cables and working to raise them from the top cable compartment. **Figure 10** shows a layout of the low voltage assembly involved in the work. The de-energized cables were planned for removal from Cubicle 5, whilst still energized conductors existing in Cubicle 4 at the bottom of the cable wireway. The rope used was not able to grab the conductors and would slip off of the cable, so the electrical contractor elected to employ a “come along” to assist in the removal, as the come along could apply more force. The first conductor was successfully removed with this new tool. Upon removing the second conductor, a small arc flash was observed in the lower compartment. Simultaneously, the lights to the plant went out. The contractor stopped work and waited for plant electricians to arrive, not knowing what had just occurred.

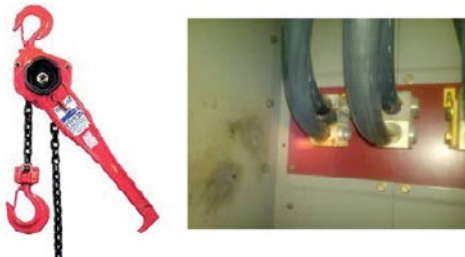
Figure 11
At left, a “come along” tool used for energized work and at right, damage to panel after phase to ground arc flash event with an upstream device with maintenance setting capabilities.

The event caused the entire plant to shut down, stopping work on the project until an analysis could be completed. It was determined that the chain of the come along had drifted below where the work was being performed and into energized Cubicle 4. Fortunately, the damage to the wall of the switchgear and come along tool was minimal, which is shown in **Figure 11**. Post event analysis proved that the chain of the come along had drifted below where the work was being performed and into an energized cubicle. The chain touched an energized terminal and arced to ground, touching both phase conductor and cabinet ground metal below the non-energized cubicle where the electrician was working. After reviewing minimal damage and completing the project while de-energized, the plant switchgear was cleaned and re-energized. Fortunately, total downtime for the plant due to this event was minimal. No loss of equipment or injury to any employee was a result of this event.

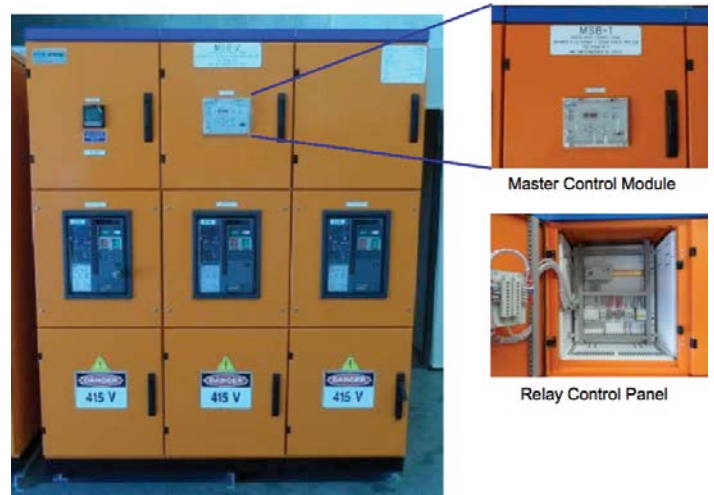
Replacement 415 volt switchboard with light detection and quenching device installed. The Master Control Module offers complete system controls and MMI display.

Figure 14 shows one of the new low voltage MCCs on the factory assembly floor prior to witness tests. Note that the panel at the left includes an incoming power meter to record energy use. The center panel includes a master control module where the light detecting sensors are connected. In the event of an arc flash, the sensors will initiate a trip signal to the quenching device which is connected at the main bus at the load side of the incoming main circuit breaker. The master controller also captures information regarding which sensor recorded the flash so the location of the arc can easily be traced after the fault is cleared. Note that this low voltage MCC is comprised strictly on air circuit breakers, with two feeder breakers that protect downstream equipment. In this application, including the maintenance switch capability to assure faster total clearing times when personnel are working in downstream equipment would also represent a best practice in mitigating potential arc flash hazards.
